Philips Cineos digital widescreen flat TV 37PF9731D 94 cm (37") LCD integrated digital with Pixel Plus 3 HD and Ambilight Surround
37PF9731D/10
FJ3.0ELA

Service information

Reference no.: **SCC_62743**

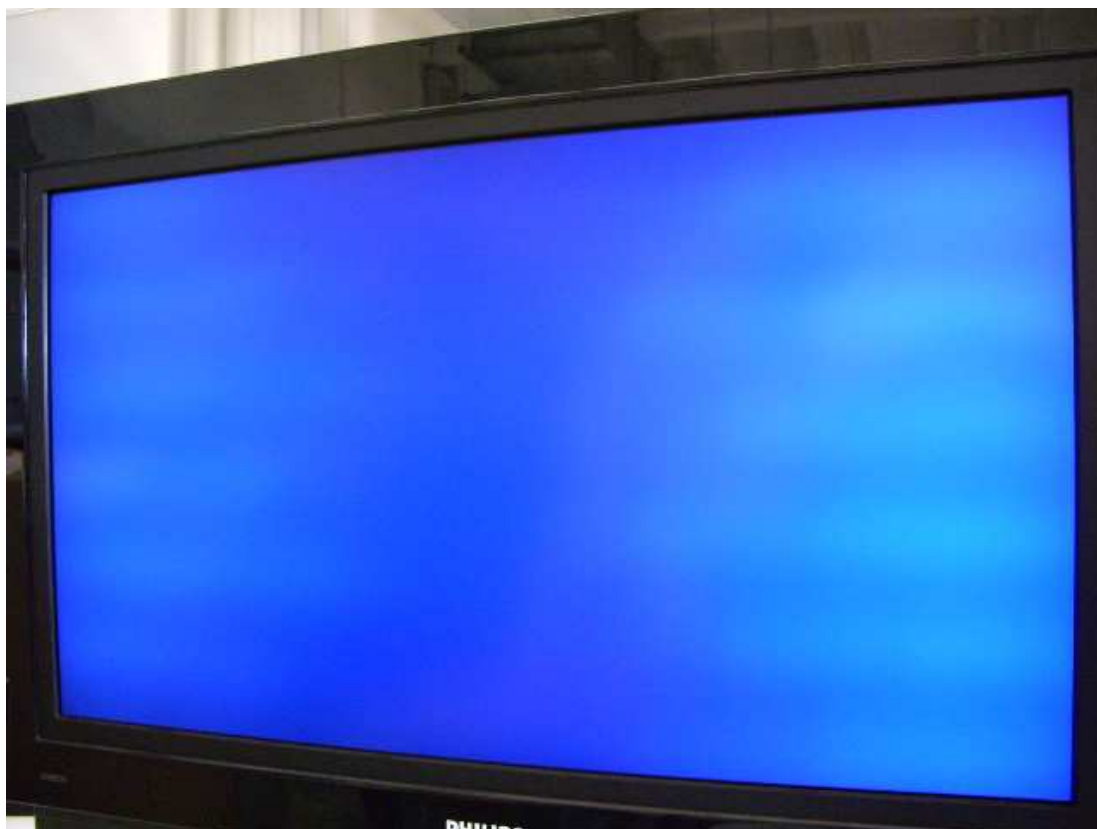
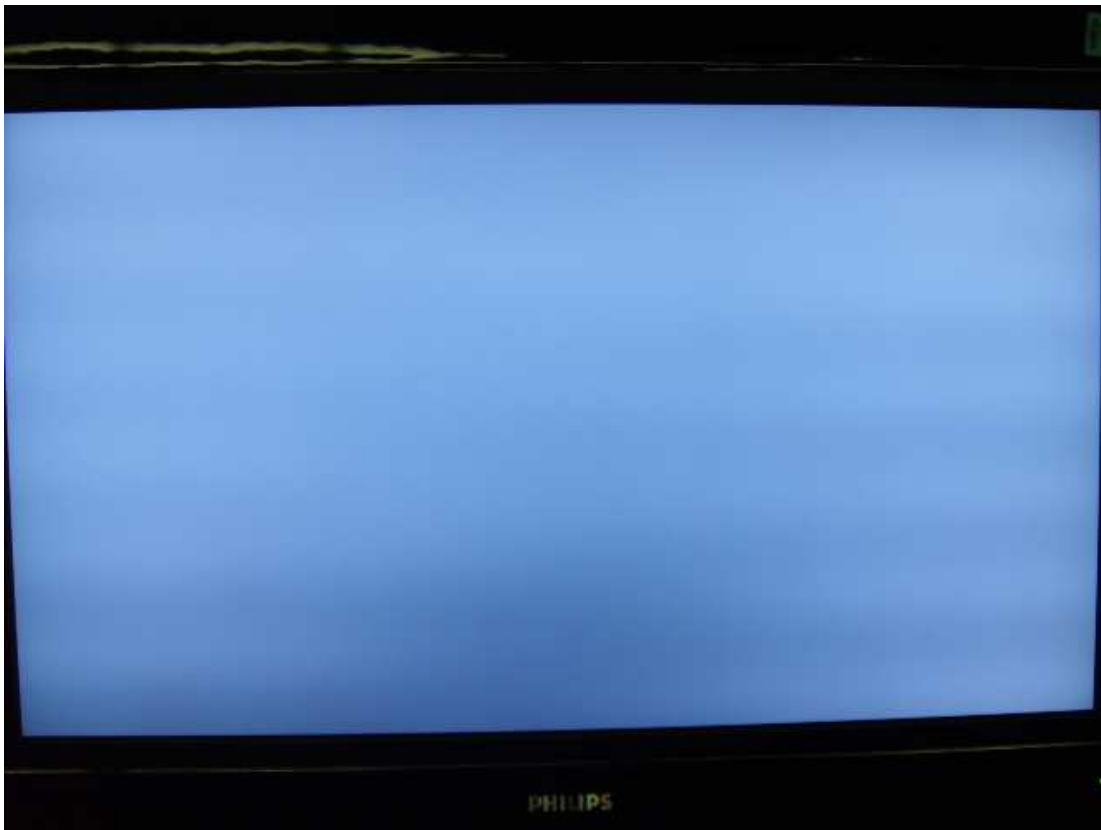
Horizontal bars and/or dark spot visible (only for 37PF9731).

- It is important to **always change the display code**, even if the display is not changed!
- The problem is caused by mercury contamination in the backlights. With the "burning in" the mercury dissolves again. With the SW and display code change, we control the backlights in another way to avoid new contamination.

- Described problem affects in no way the 32PF9731(D) or 42PF9731(D) !
- For an example of the symptom refer to the pictures below.
- The described rework is **not** mandatory for all incoming sets, but if the symptom is visible, perform this change to prevent that the customer will complaint when it becomes worse!

- 1) Upgrade the main TV software to version 0.87.0.0 (or later).
- 2) Adapt the "Display Code": activate SAM, select "Options" -> "Option Numbers" -> "Group 2" and change the option numbers according to table below. Do not forget to store the new option codes properly: after changing the code, return to the "Option Numbers" menu, select "Store" -> press "OK" (or go to the right) and press "OK" **again**. The display must now show "Store completed". **To double check:** Switch the set "off", wait 1/2 minute, switch the set "on" again and check in the SAM whether the option code is changed correctly.
- 3) Change the display code (with a pen) on the option code sticker to this new value (this, to prevent repeat repairs).

4a) **If it is a workshop repair:** The set must be "burned in" for 24 hours under the following conditions:

- Maximum contrast.
- Lightsensor "off".
- Dynamic Contrast "off".
- Not in cold conditions; normal room temperature is OK.
- Normal picture content.

4b) **If it is a home repair:** The set must also be "burned in" for at least 45 minutes under the same conditions as mentioned above. This can already be started before changing the option code and upgrading the software.
